Re: 8150 West Sunset Boulevard; CHC-2016-2522-  
HCM; Historic-Cultural Monument Application  
for the Lytton Savings

**Table 2**  
**Comparison of Historic and Current Appearance**

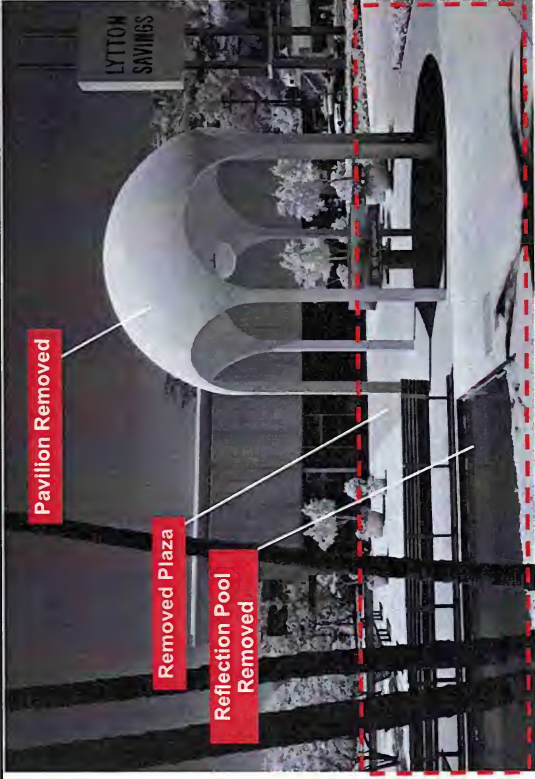
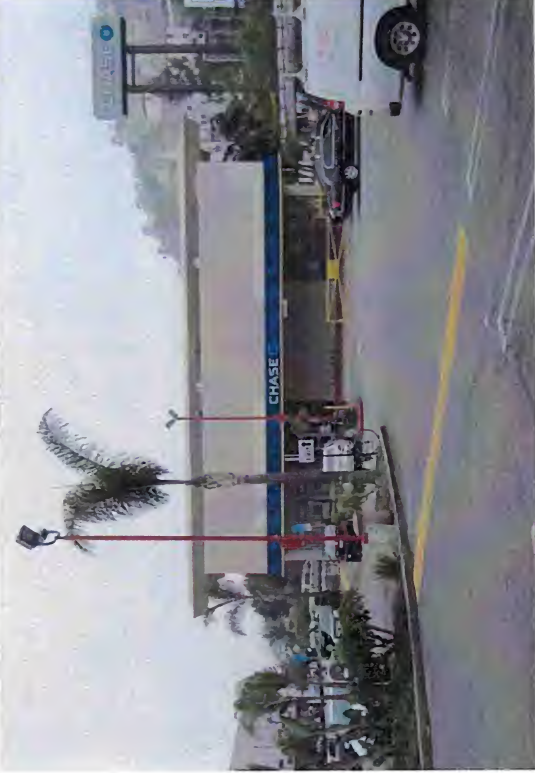
Photo	Original Appearance	Current Appearance
3

<p>June 22, 1960 (Shulman Archive, Getty)</p>

<p>2013</p>

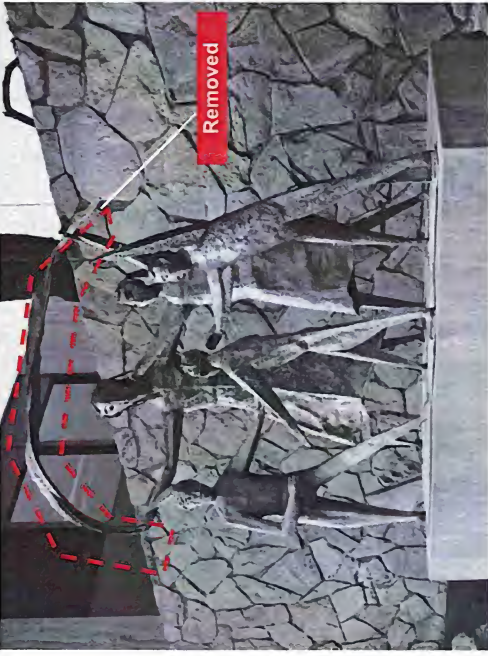
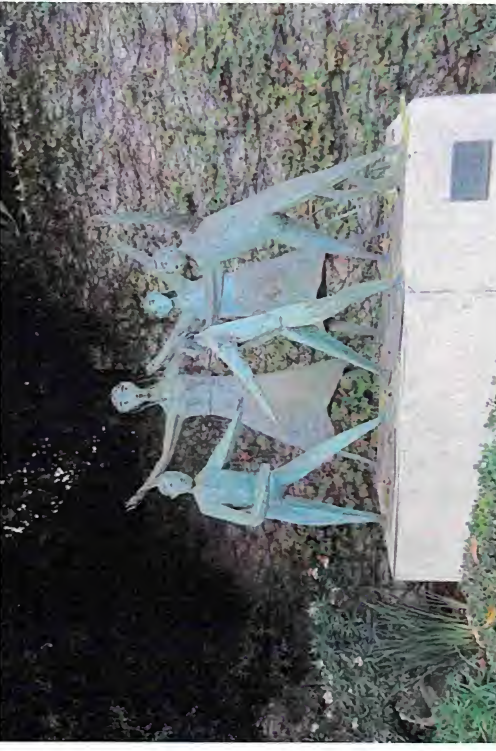
Photo	Original Appearance	Current Appearance
7

<p>June 22, 1960 (Shulman Archive, Getty)</p> <p>Removed</p>

<p>2013</p>
8

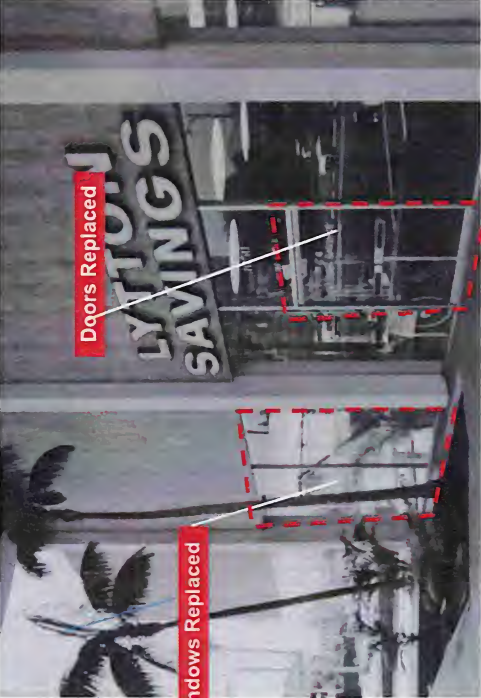
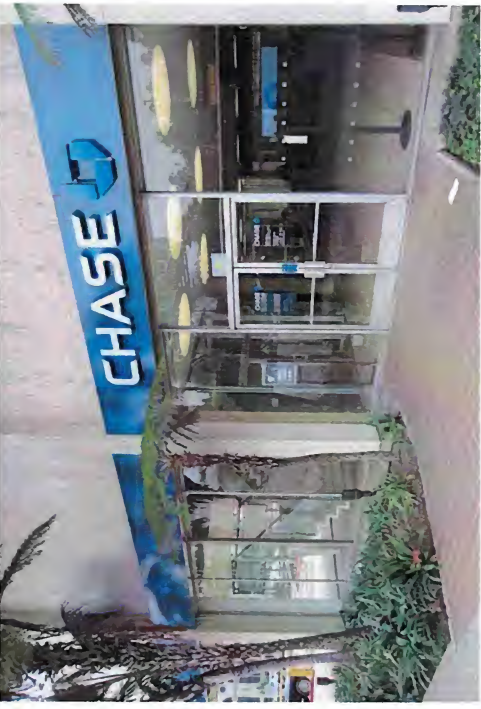
<p>June 22, 1960 (Shulman Archive, Getty)</p> <p>Windows Replaced</p> <p>Doors Replaced</p>

<p>2013</p>

- Replacement, alteration and infill of the Bank's glazing and fenestration
- Removal of the auto teller, automobile driveway and original parking lot design

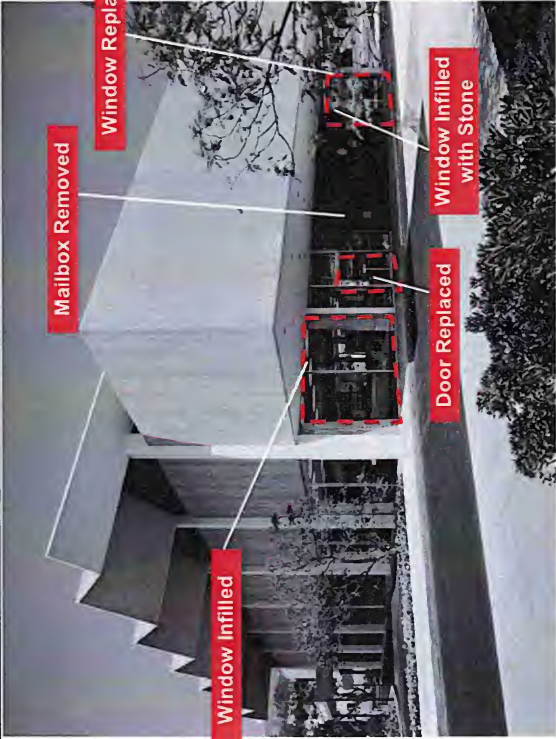
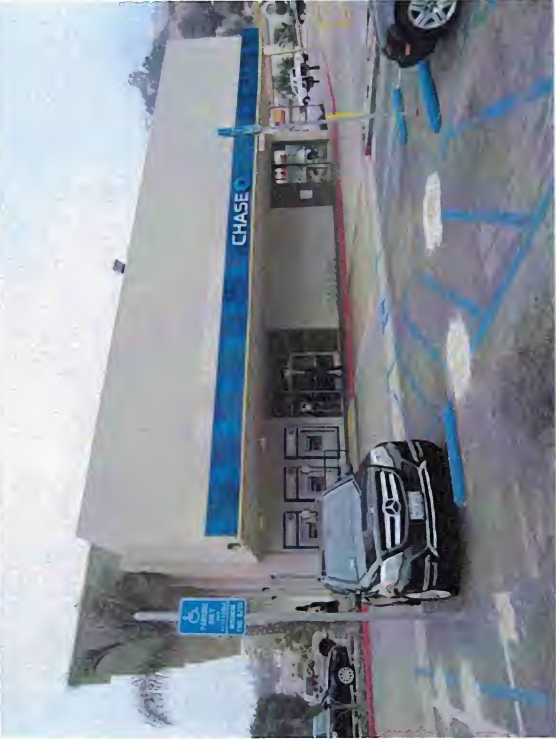
Photo	Original Appearance	Current Appearance
9

<p>June 22, 1960 (Shulman Archive, Getty)</p>

<p>2013</p>

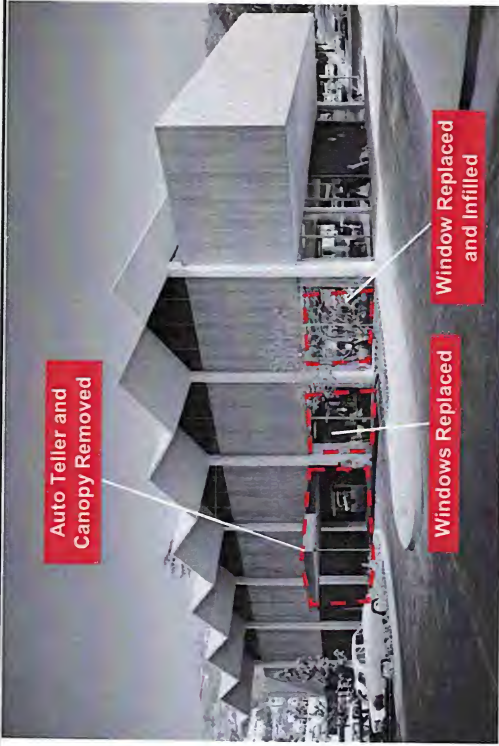
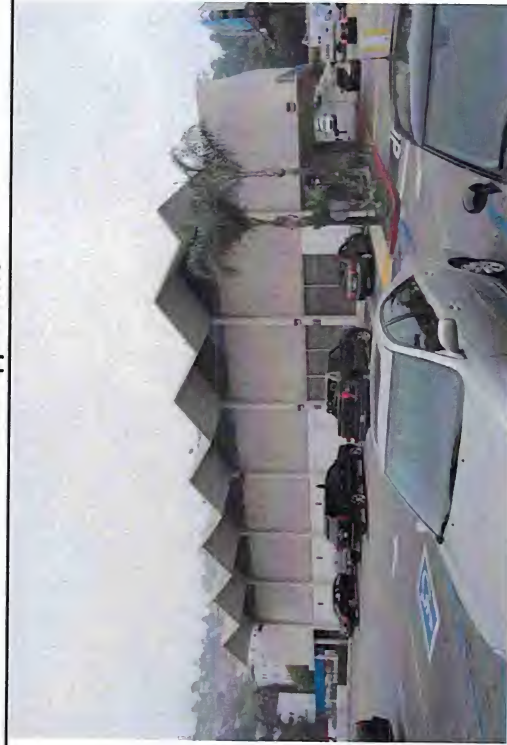
Photo	Original Appearance	Current Appearance
10

<p>Auto Teller and Canopy Removed</p> <p>Windows Replaced and Infilled</p> <p>June 22, 1960 (Shulman Archive, Getty)</p>

<p>2013</p>
11

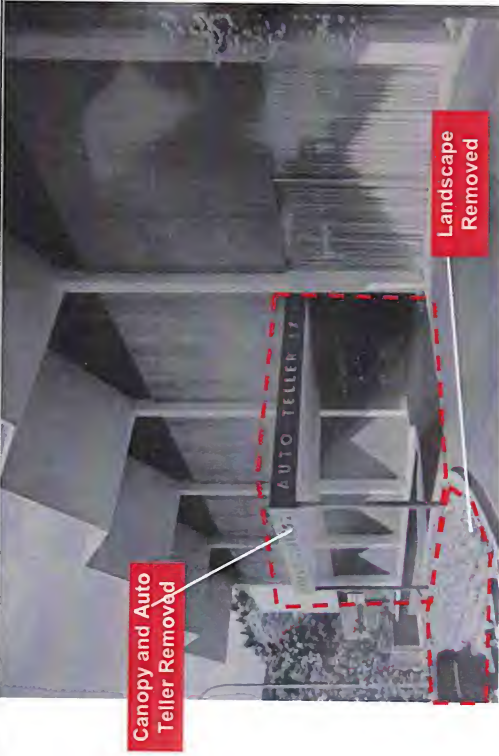
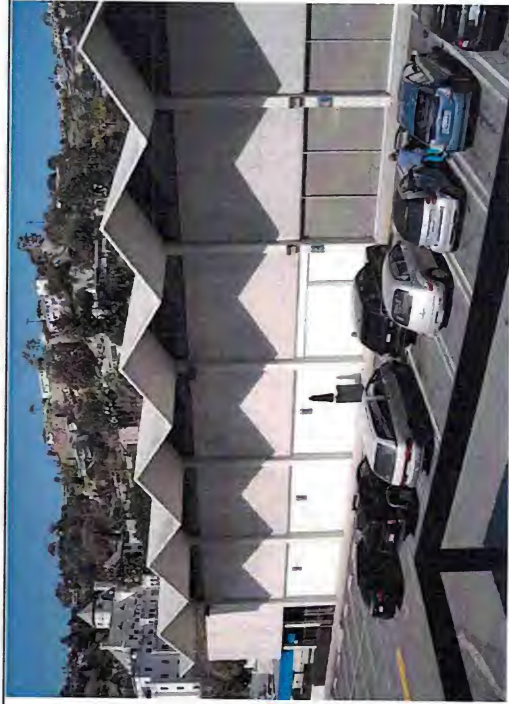
<p>Canopy and Auto Teller Removed</p> <p>Landscape Removed</p> <p>June 22, 1960 (Shulman Archive, Getty)</p>

<p>2013</p>

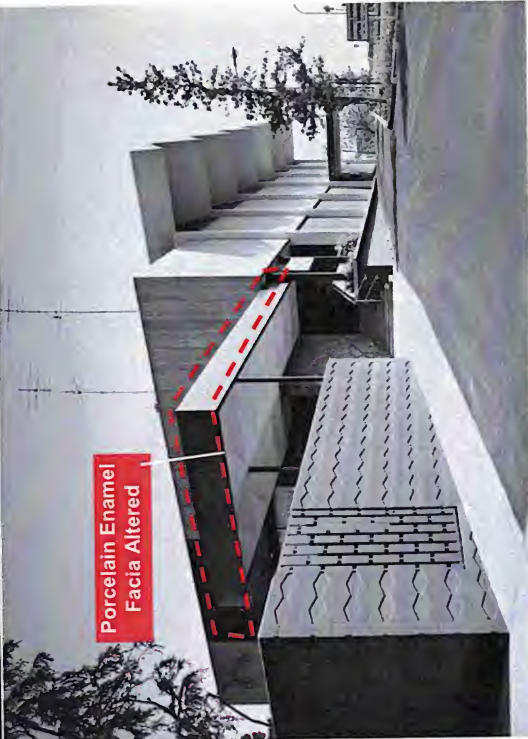
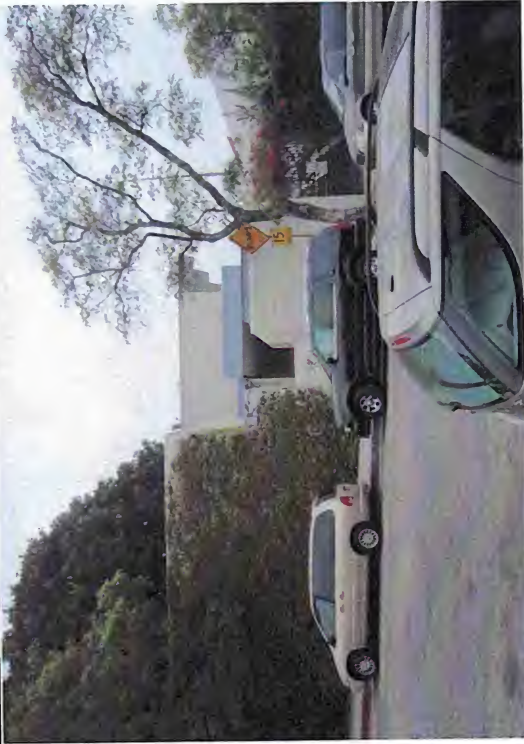
Photo	Original Appearance	Current Appearance
12

<p>June 22, 1960 (Shulman Archive, Getty)</p>

<p>2013</p>
13

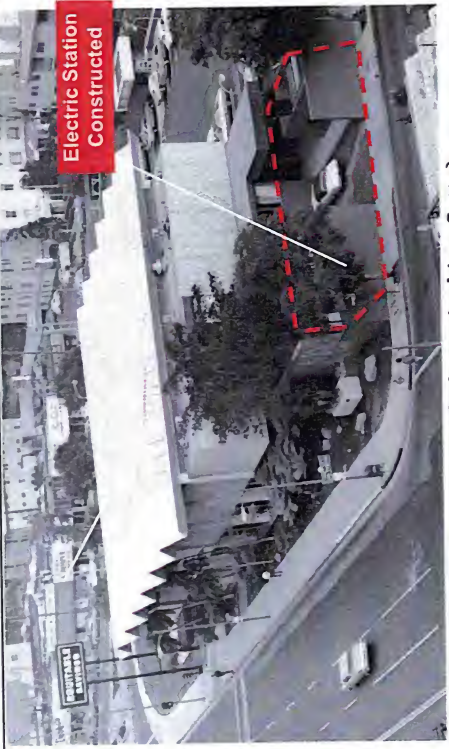
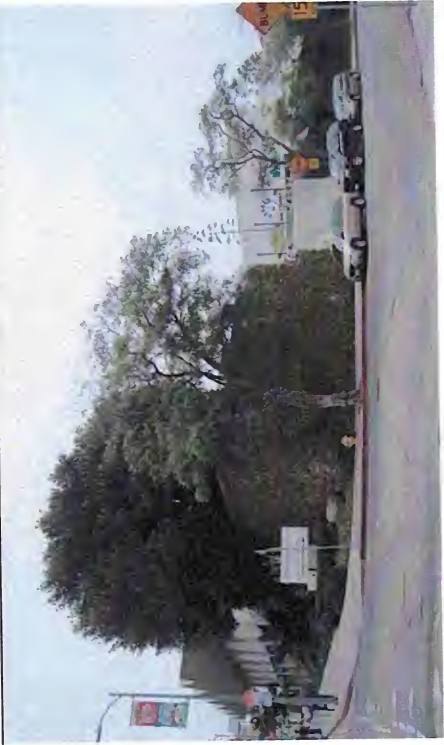
<p>June 22, 1960 (Shulman Archive, Getty)</p>

<p>2013</p>

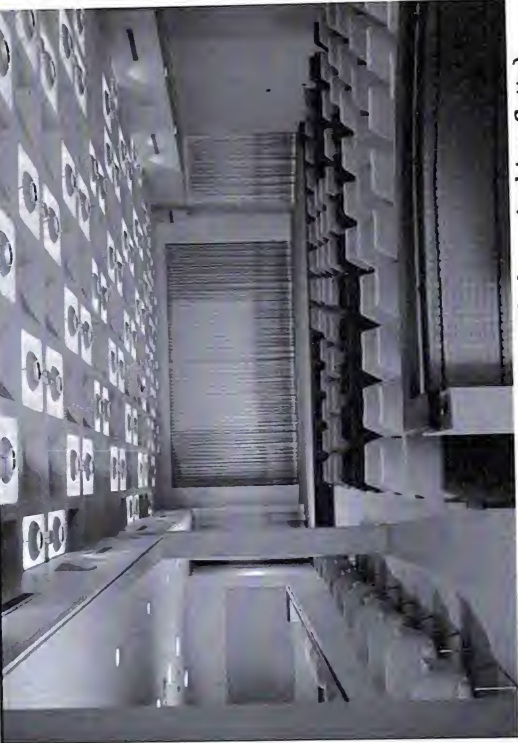
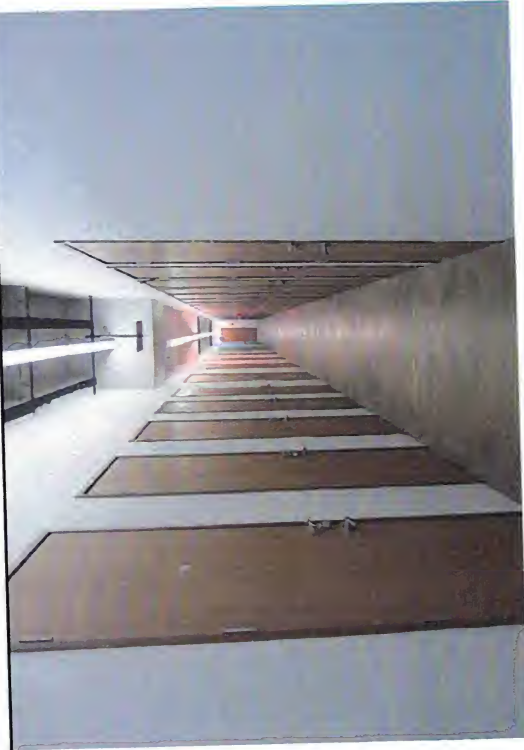
Photo	Original Appearance	Current Appearance
20

<p data-bbox="906 1157 938 1787">Lytton Center Auditorium 1962 (Shulman Archive, Getty)</p>

<p data-bbox="890 562 922 632">2013</p>

- Removal of the museum use, including entrance, lobby, galleries, and auditorium to allow for a health club and storage facility such that the Lytton Center is no longer an identifiable feature of the property
- Removal of the public Plaza with pavilion, reflecting pool and Modern landscaping and conversion of area into an asphalt parking lot
- Removal of Lytton's private patio on west elevation, including decorative concrete blocks, metal gate and private parking area
- Unsympathetic replacement of travertine panels on east elevation
- Alteration of sculpture *The Family* by David Green
- Removal of Lytton Savings and Loan Pole Sign
